Smoke and Dye-Water Observation Summary

Western Run Pilot Project - Baltimore Maryland

INSPECTION REPORT

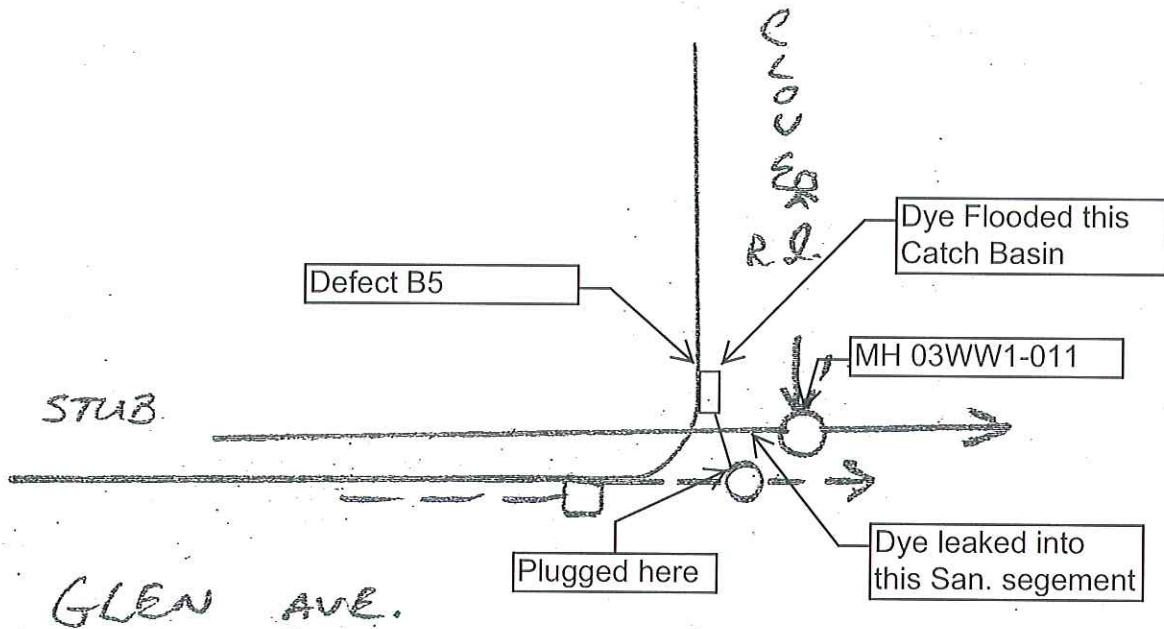
Dye Test 86

Additional Comments: The Catch Basin never Flooded. Alot of the water leaked back into the _____
Main Storm line through breaks and holes.

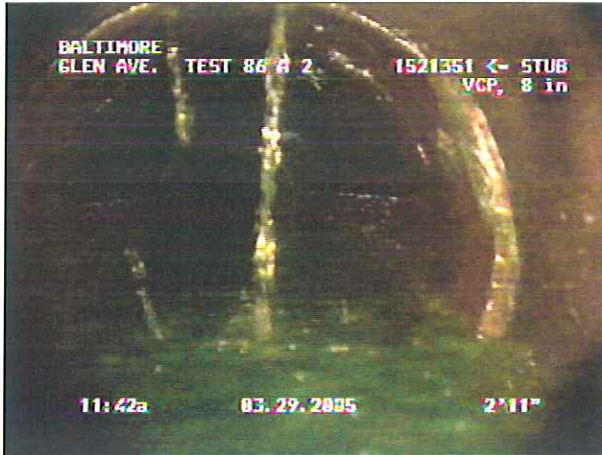
IMAGE: 10a, TAPE #: JAM 2, 00:11:19
2.92FT, Infiltration Gushing at joint at 11 o'clock to 3 o'clock

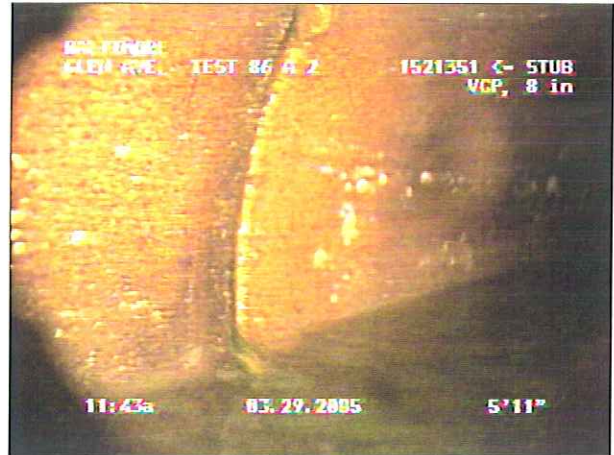
IMAGE: 11a, TAPE #: JAM 2, 00:12:30
5.94FT, Infiltration Running at joint at 08 o'clock to 10 o'clock
